# The Virgin Islands Consortium

## WAPA Says Composite Pole Broke Because Of Pressure From Fallen Tree

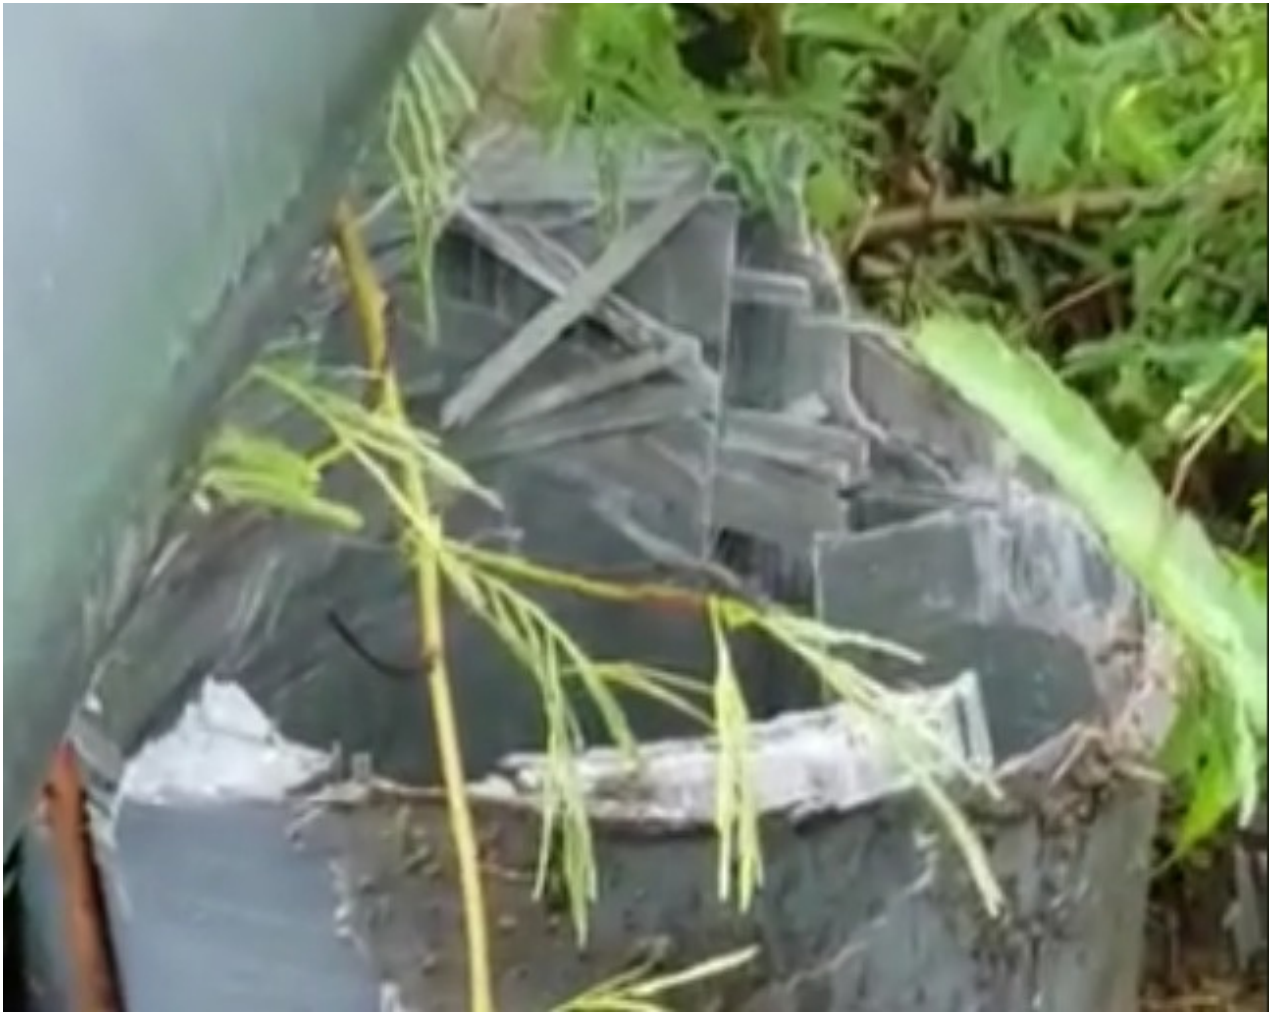
WAPA spokesman John Greaux said a preliminary investigation was conducted into what caused a new composite material pole to fall on Centerline Road on St. John.

“The pole on Centerline was taken down by a large tree that came down on the primary service lines and toppled the pole,” Mr. Greaux said. “The pole did not structurally fail.” Mr. Greaux was responding to an inquiry by Governor Albert Bryan during Mr. Bryan's Friday update on Hurricane Dorian. The video was published on the Consortium's Facebook platform and has garnered more than 70,000 views as concerned residents questioned the veracity of the new poles.

Mr. Greaux sought on Saturday to assure residents that the poles was damaged by debris and did not fail on its own.

“It was that impact (by a falling tree), wind, the weight of the tree, plus the weight of the line brought it down,” he said.
